Banking on Natural Fibers

by Greg Northcutt

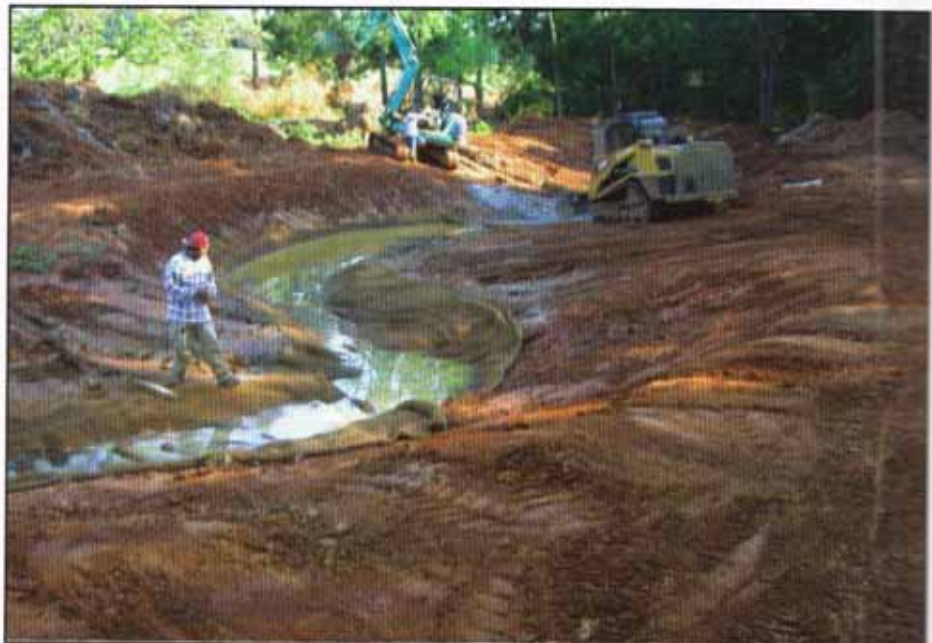
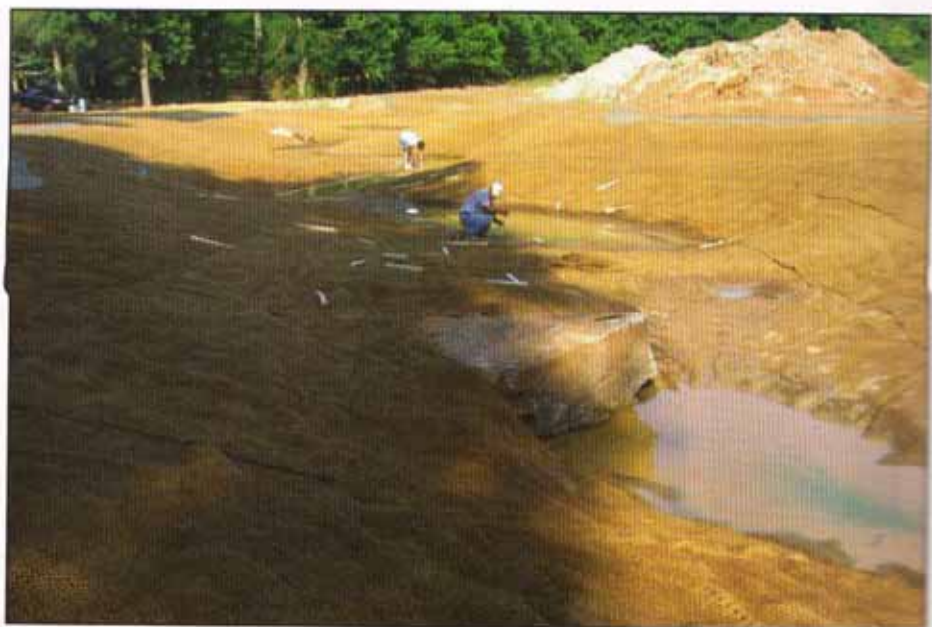
Restoration of White Creek meant re-creating the rural streams natural meandering type of channel (above) and adding pools, boulders and other features for fish habitat while installing natural fiber products, like coir erosion control blankets, to stabilize the streambanks (below).

of about one-half mile of White Creek and more than 1,000 ft. of three other smaller tributaries. The original meandering stream was channelized and straightened as part of previous farming operations. Over time, the channel became even more degraded and unstable. Nelson's crew relocated the stream into a meandering channel. Heavy machinery, including excavators and front-end loaders, were used to produce a "C"-type stream based on the Rosgen stream classification system. Characteristics of a "C"-type stream include a meandering channel, with a slope of two percent or less and a series of riffles and pools.

After creating the new, stable channel for White Creek, Nelson and his crew installed riffles, log vanes, and other habitat and stabilization structures at various locations along the stream and the tributaries. These habitat and stabilization structures, made of cedar logs and boulders, are designed to reduce scour energies on the outside bends of the meandering stream. Along with strategically placed boulders, they provide habitat for native warm-water fishes.

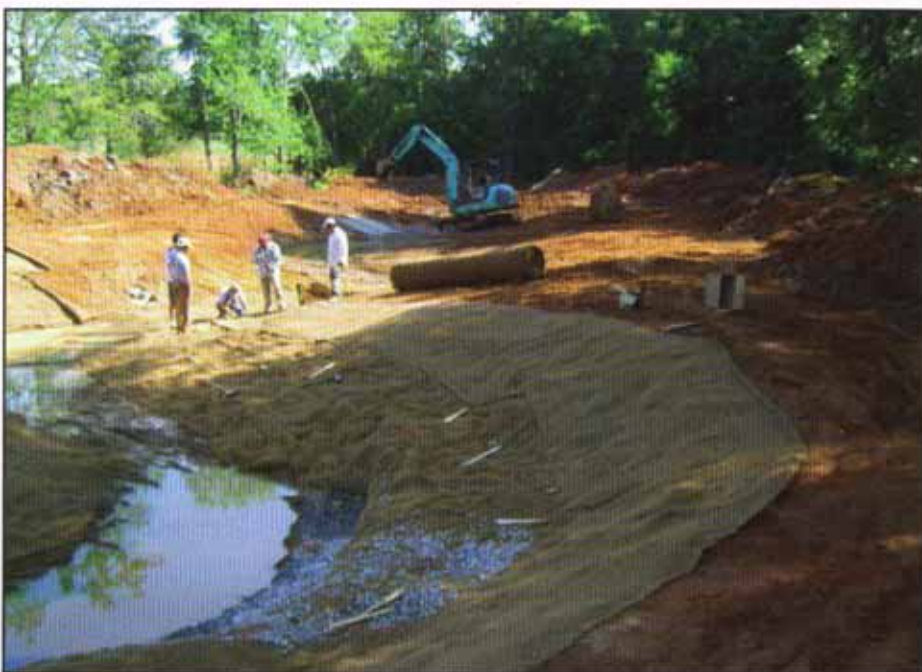
One type of woven coir erosion control blanket, designed to protect soil from higher flow velocities, was installed in the stream channel. A coir blanket with a more open weave was placed higher up the stream banks where stream flows are likely to be slower.

"The coir rolls help absorb and deflect the flow energies, especially on the outside meander bends, and assist in protecting the stream banks from eroding," Nelson says.

Two types of degradable erosion control blankets were used to control erosion of the restored stream bed and banks. The blankets are woven from machine-twisted bristle coir twine and have a functional life of about four to six years. The open-weave construction allows vegetation to grow up through the openings in the blankets. It also allows trees and shrubs to be planted through the mat without cutting it and reducing its strength.

The BioD-Mat 70 blanket was installed in the stream channel where erosive forces typically are higher than on the streambanks. This blanket is recommended for slopes as steep as 1:1 and for short-term flow velocities as high as 12 ft./sec. "The mat also collects sand, silt and pebbles that the stream carries naturally," Nelson said. "The sediments cling to or are trapped in the voids in the mat and assist in creating habitat for macro-invertebrates."

The lighter weight, less-densely woven BioD-Mat 40 product was used to protect the area of the streambanks and flood prone areas above the active channel. It is recommended for slopes of 2:1 or less and flow velocities up to 8 ft./sec. "Because of the expected lower flow velocities in these higher areas compared to the active channel, these higher areas can be stabilized with a lighter-weave mat," Nelson says.

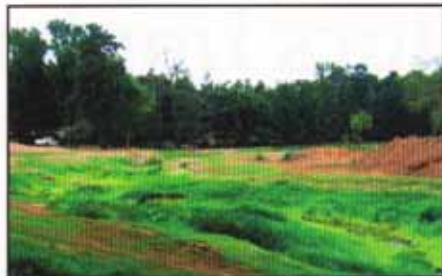
Not long after construction was completed, this stand of grass is helping to control erosion.

After protecting all disturbed areas with the blankets, they were seeded with millet to help temporarily control erosion. "The millet germinated well and produced a nice, uniform stand," Nelson notes. This winter, bare root native mast trees, including oak and hickory, and fruiting shrubs, like elderberry and dogwood, are being planted through the coir and jute blankets to assist in providing permanent stabilization, erosion control, and shading.
